## **Key Highlights & Lessons Learnt: Warehouse Blast in Tianjin, China (12 August 2015)**

Prepared by:  
Chemical Industries Council of Malaysia  
October 2015

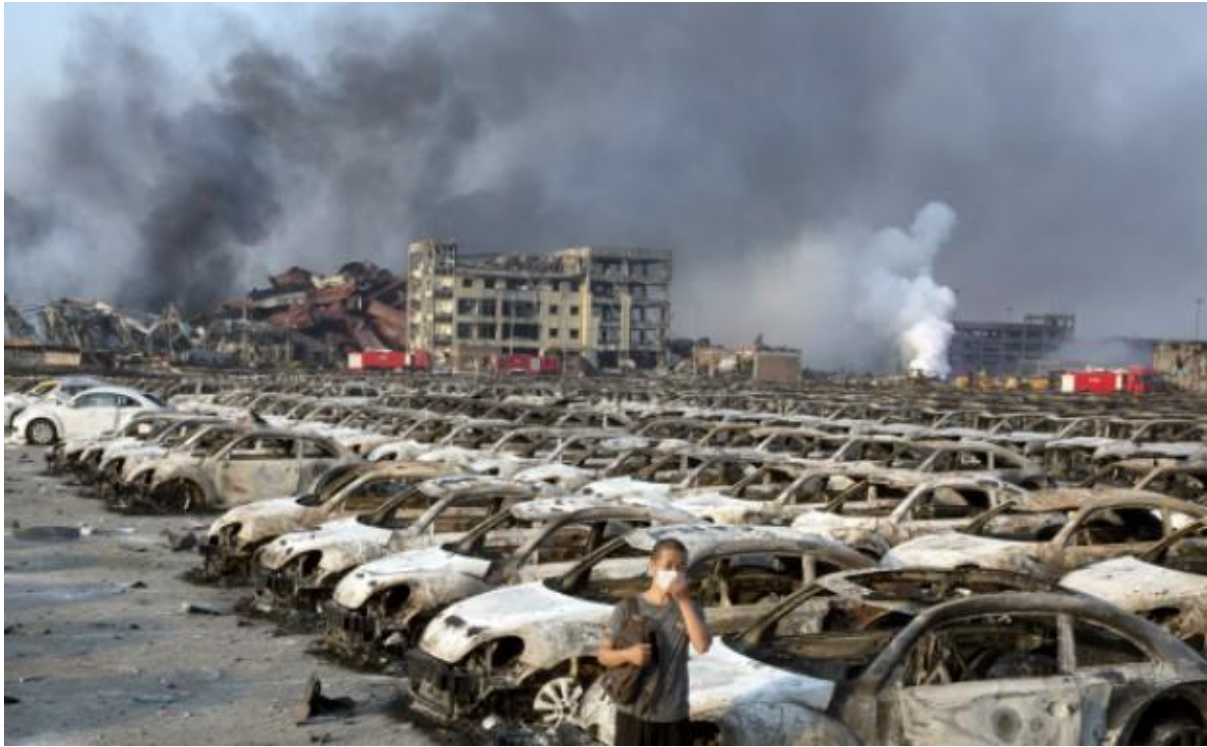
Source Photo: AP / South China Morning Post

The second blast about a few minutes later could be due to the acetylene igniting the ammonium nitrate which produced a massive blast equivalent to 21 tons of TNT. It was detected by the Japanese weather satellite and images showed walls of flame enveloping buildings and rows and rows of gutted cars at the import facility.

This incident is a clear reminder to the chemical industry of the blatant abuse of power and dereliction of duty by the owners and the relevant government agencies. The explosions and their aftermath raised questions on industrial safety standards; as well as the enforcement of residential zoning regulations; government transparency and the adequacy of fire fighters training.

In Malaysia, we have adequate laws and regulations covering chemical warehouse safety but more importantly the chemical industry must voluntarily implement appropriate codes and best practices at their chemical warehouses. CICM has the Distribution Code covering logistics and chemical warehouse operations and our members can request for CICM's assistance.
